# Wood Boring Beetles

# Wood Destroying Insect Inspection Report

# INSPECTION GRAPH

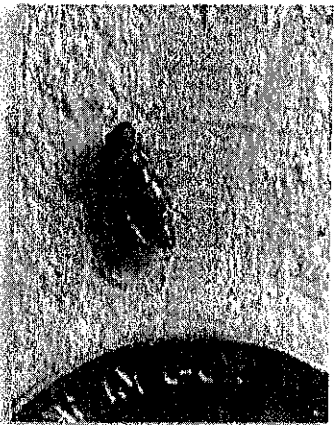
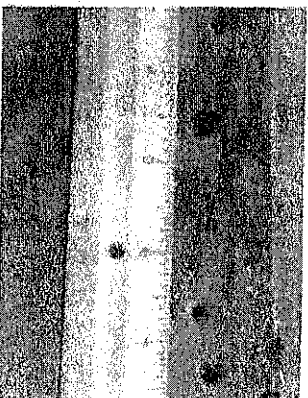
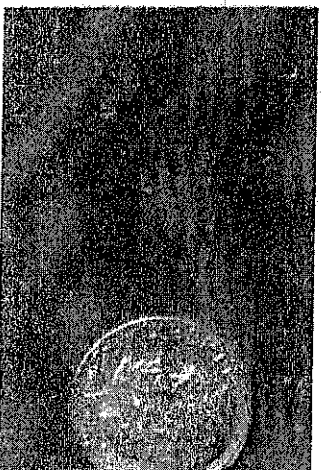
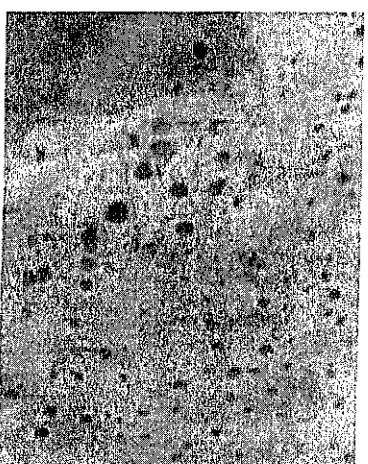
## Powderpost Beetles

- Their presence is only apparent when they emerge as adults, which leaves behind pinhole-sized openings, often called "shot holes".
- Pin-sized exit holes

- Feed on Starch, Sugar, or Proteins
- Leave fine powder
- Larvae determines Activity
- Damage hardwood floors, trim, molding, furniture
- Can continue cycle for generations

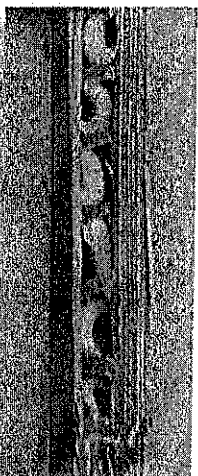
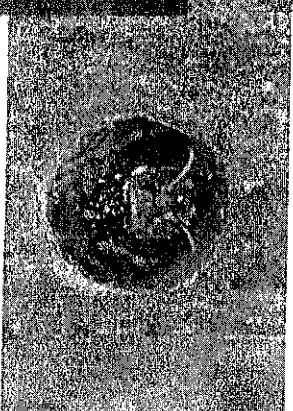
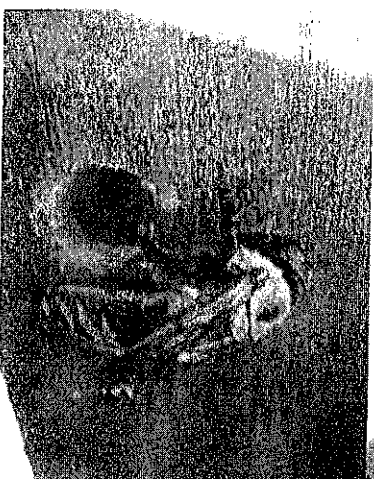
# Carpenter Bees

- Active Mid May through August
- Female excavates chambers to lay eggs (6 – 48 inches)
- Male appears aggressive but has no stinger
- Female tends to larvae and young
- Typically larger than bumble bee
- Males have white patches on their face
- One pair per nest
- Next generation will come back to same area the following year to lay eggs
- Carpenter bees prefer natural wood

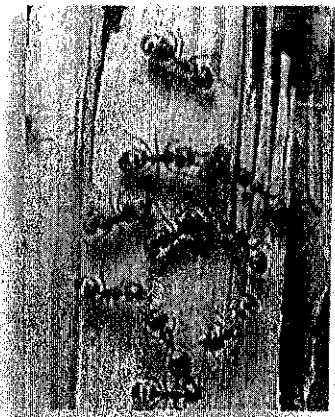
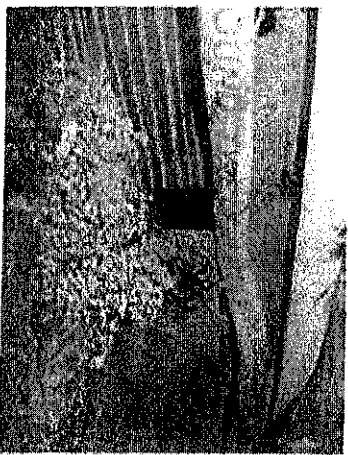
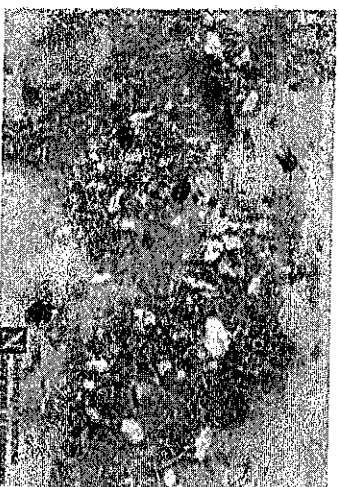
# Carpenter Ants

- Feed on sugar and protein: dead and living insects, honeydew, honey, meat, jelly
- Forage up to 100 yards to find food
- Can have more than one colony
- Typically forage between sunset and midnight
- Distinguishable by their bent antennae, pinched waist, 2 separate sized sets of wings
- Destroy wood for colonization; nesting purposes and laying eggs
- Prefer damp wood but will chew into adjacent sound wood as the population grows
- Nests are created by excavating extensive networks or galleries by chewing moist or decaying wood
- Frass is made when the carpenter ant "cleans" out the wood and waste products (excrement, dead insects, cast skins, uneaten food)
- Frass is used to help locate carpenter ant activity/nests

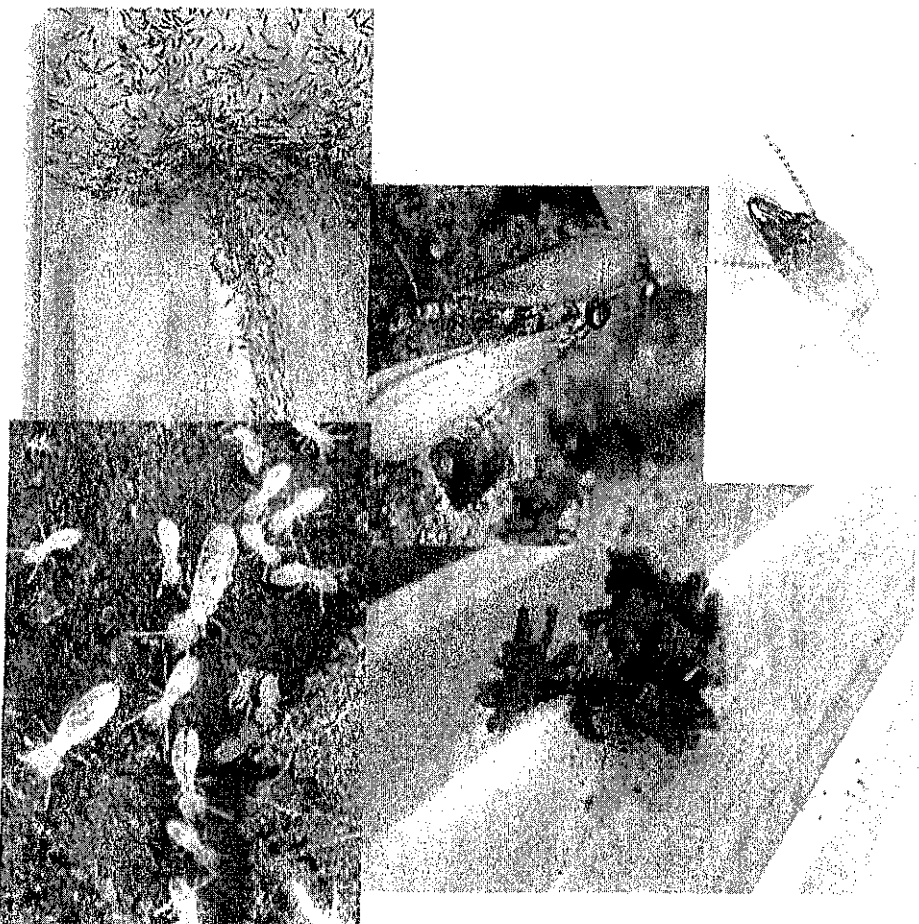
# Subterranean Termite Facts

- 13 to 14 colonies of termites in an acre of land.
- As many as 2 million termites per colony -- depending on age of colony.
- A typical home may have 3 to 4 colonies situated under or around it.
- The termites on Earth outweigh the humans on Earth.
- Termites cause more damage to homes in US than storms and fires combined.
- Every year, termites cause more than two billion dollars in property damage, repair and control costs in the United States alone.
- Caste system of King, Queen, Soldiers, and Workers.

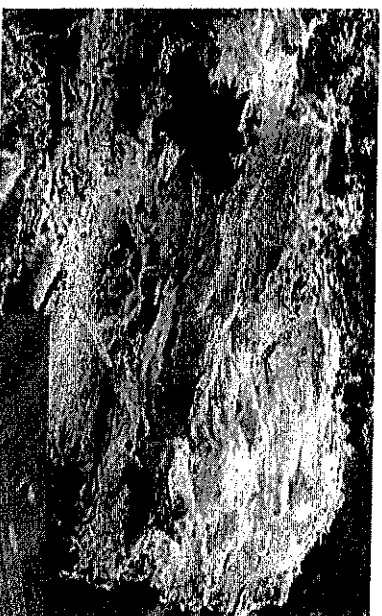
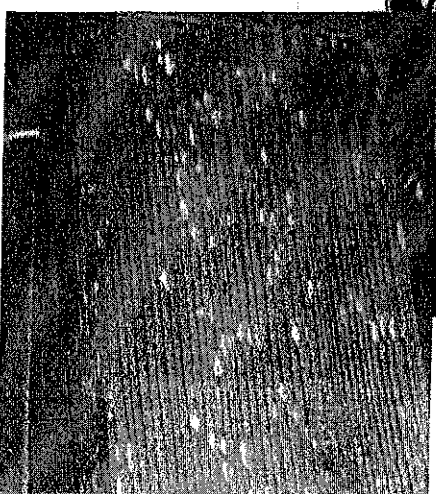
# White Pocket Rot

- Wood decayed by white-rot fungi is fibrous and spongy, and is bleached.
- Sometimes it has thin, dark lines around decayed areas.
- The wood does not shrink until decay is advanced.
- Fungus that attacks the heartwood of living trees.
- Once the tree is harvested the fungus dies.
- No control measures are necessary.

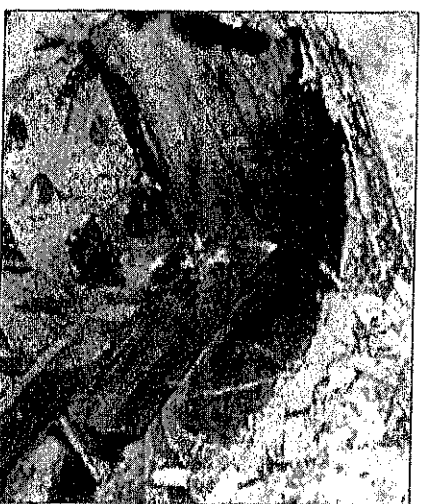
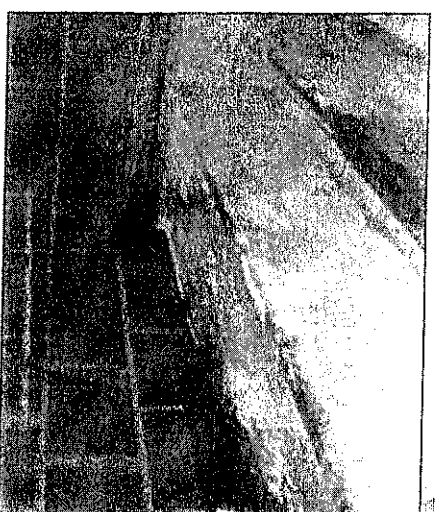
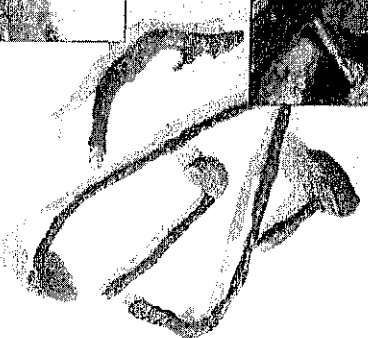
# Water Conducting Fungus

- *Poria incrassata* is the only fungus that can conduct water very far
- *Poria* infested wood is often mistakenly identified as subterranean termite damage
- This type of fungus can transport water for several feet through large root-like structures called rhizomorphs
- Once established, it can quickly spread through a building and destroy large areas of flooring and walls in as little as a year or two
- The rhizomorphs that characterize these fungi can be up to an inch in diameter and white to black depending on their age.

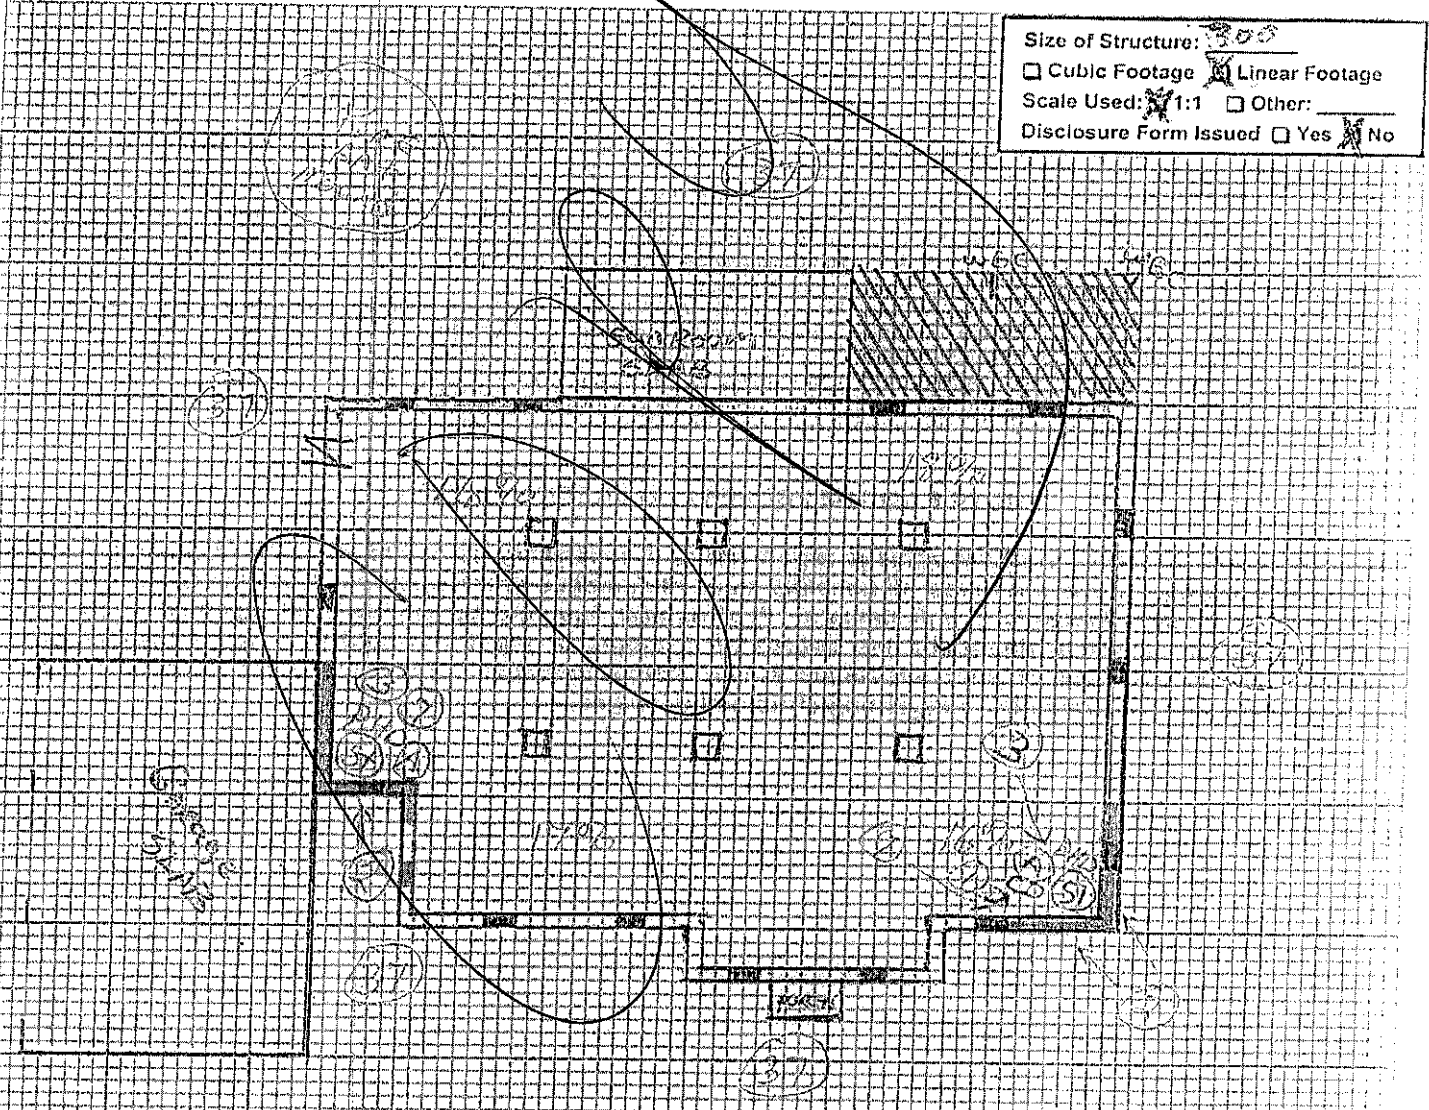
CODE:  ACTIVE INFESTATION VISIBLE=A  SUBTERRANEAN TERMITES=ST  DRYWOOD TERMITES=DT  WOOD BORERS=WB  
 POWDER POST BEETLES=PPB  \*WOOD DECAY FUNGI=WDF  \*MOISTURE CONDITION=M  PREVIOUS INFESTATION

CONDUCTIVE CONDITIONS:  POSSIBLE HIDDEN DAMAGE=PHD  EXISTING VISIBLE DAMAGE=⊙  INACCESSIBLE AREAS=\*  
 WOOD TO GROUND CONTACT=WGC  INADEQUATE VENTILATION=IV  STANDING WATER=SW  CELLULOSE DEBRIS=CD

INSPECTORS STATEMENT LOCATION OF VISIBLE DAMAGE: NONE AT TIME OF INSPECTION  
 TYPE OF TREATMENT:  Baiting System  Liquid Treatment  Physical Barrier  Partial Treatment  Other:

TREATMENT DATE: 1/23/13 PRODUCT: SENTRION / PREMISE ESTIMATED  GALLONS /  STATIONS: 20  
 Water Well:  NO  Yes - # of Feet \_\_\_\_\_ Access Information: \_\_\_\_\_
